**Re: Hydro One Kenora OC Washroom (BGIS Project No. HONI001724)**  
**60 Rabbit Lake Road, Kenora, ON**  
**Certification of Substantial Performance**

# Site Report

Project:	<b>BGIS Kenora Hydro One OC Shower Stall</b>	Report No.:	<b>3</b>
Location:	<b>60 Rabbit Lake Road, Kenora, ON</b>	Date of Visit:	<b>Oct. 6, 2022</b>
Owner:	<b>Hydro One Networks Inc.</b>	KAL Project File:	<b>21070</b>
Contractor:	<b>M Builds (NOW) Limited Partnership</b>	Owner's File:	<b>HONI001724</b>
Site Representative:	<b>Chris Boyechko &amp; Eric Esarte</b>	Building Permit:	<b>2022-0025</b>

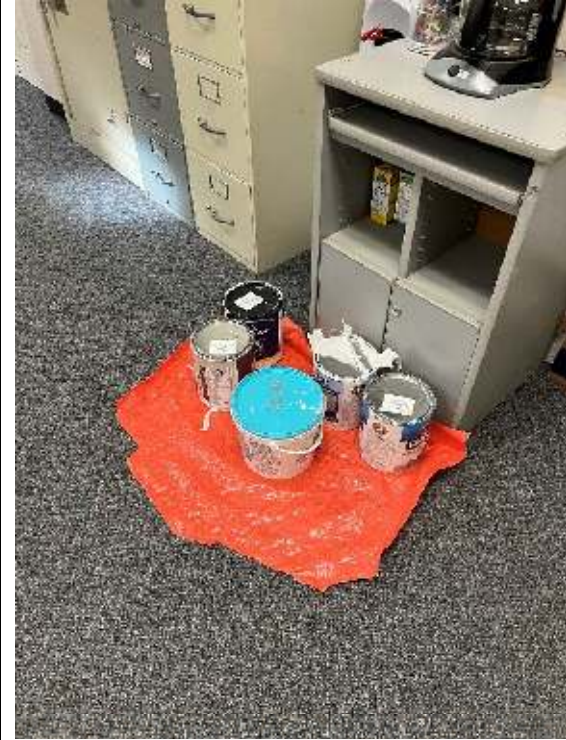
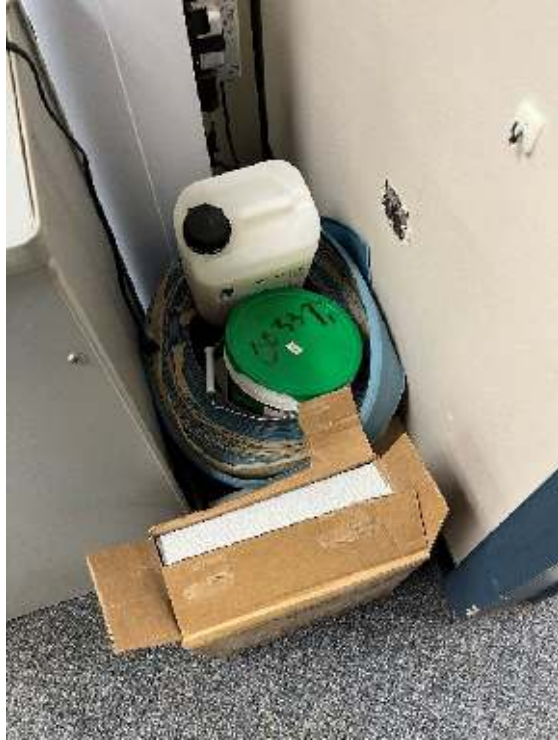
- 1.1.1 The site was clean and orderly.
- 1.1.2 Spare materials were stockpiled adjacent to the door to Washroom Vestibule 2, for transfer to the Owner.  
– Photos 1 & 2

Photographs 1 & 2: Spare materials

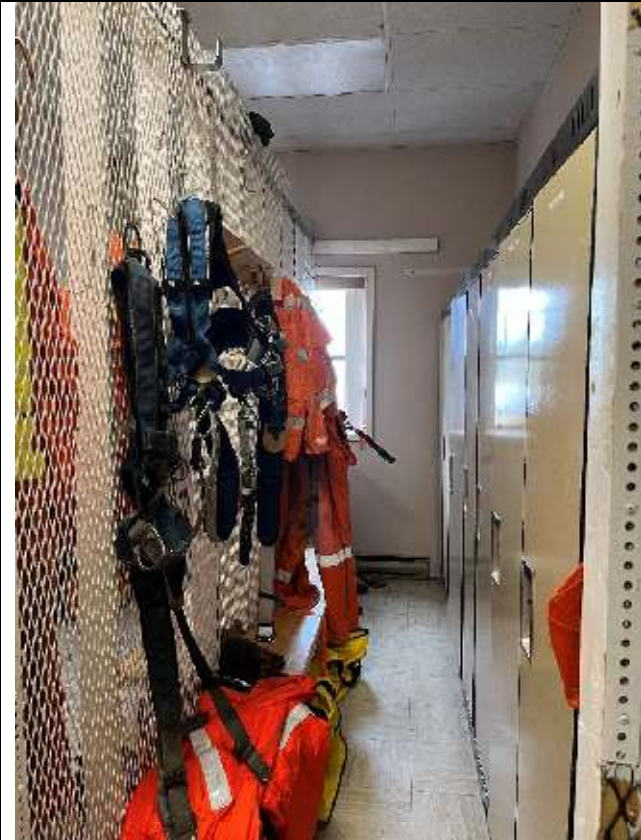
- 2.1 The existing lockers (8 no.) have been relocated from the new shower space to the eastern lockup/drying area in Locker Room 19. The clothes hooks have been relocated to the west wall of the lockup/drying area and securely affixed to the screen support members. The remaining 3 no. lockers from the new shower space were handed over to the Owner to be re-purposed. – Photo 3

Photograph 3: Lockers relocated from new shower space to Locker Room 19.

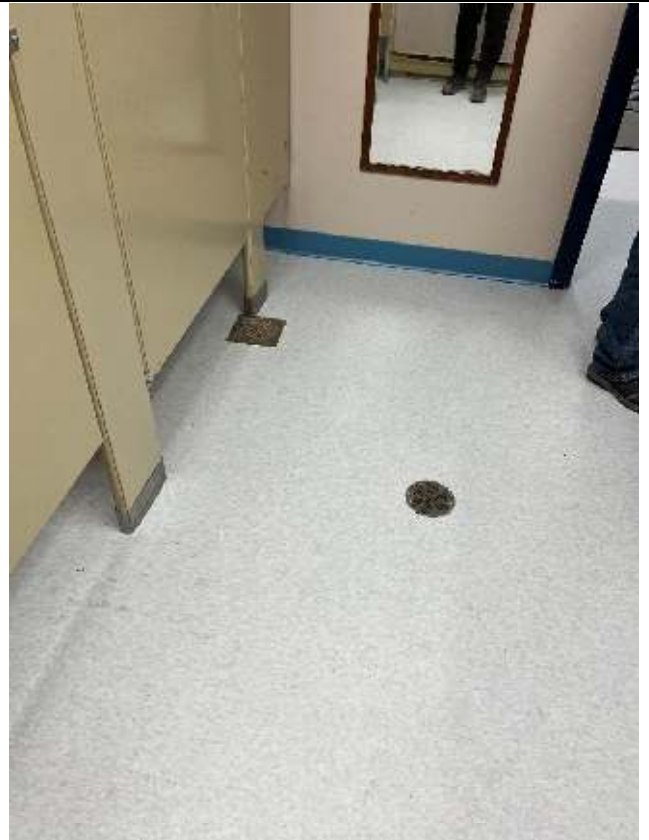
- 2.2 The flooring and rubber base were replaced at Washroom 1. – Photo 4
- 2.3 A new shower room was installed complete with exhaust fan, general lighting, emergency lighting and accessories including shower curtain, seat, locker, shelf and robe hook. Warm water was provided to the shower fixture. Positive drainage to the floor drains was provided at the newly tiled floor. The acrylic wall panels were installed to lap over the coved tile base. – Photos 5 to 8

Photograph 4: New flooring and base at Washroom 1

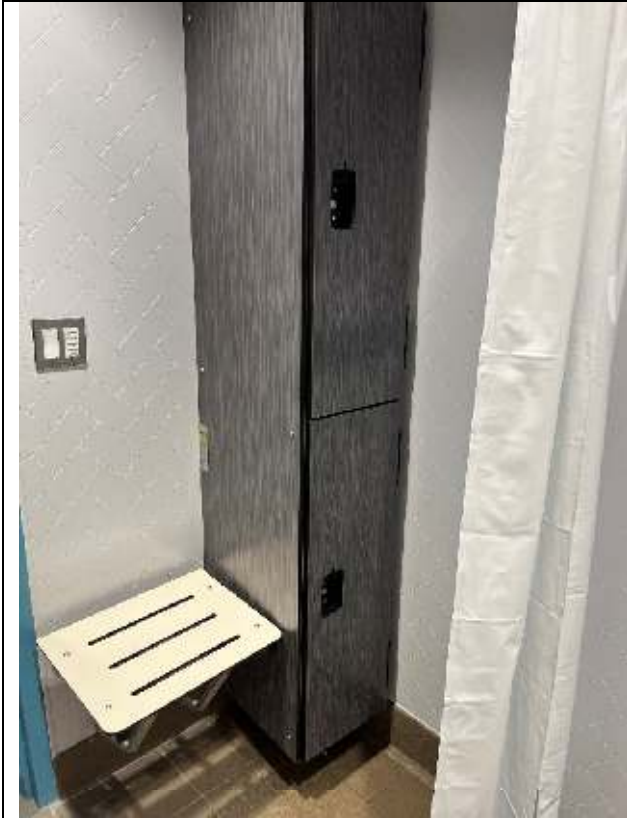
Photograph 5: Locker and seat and New Shower 3

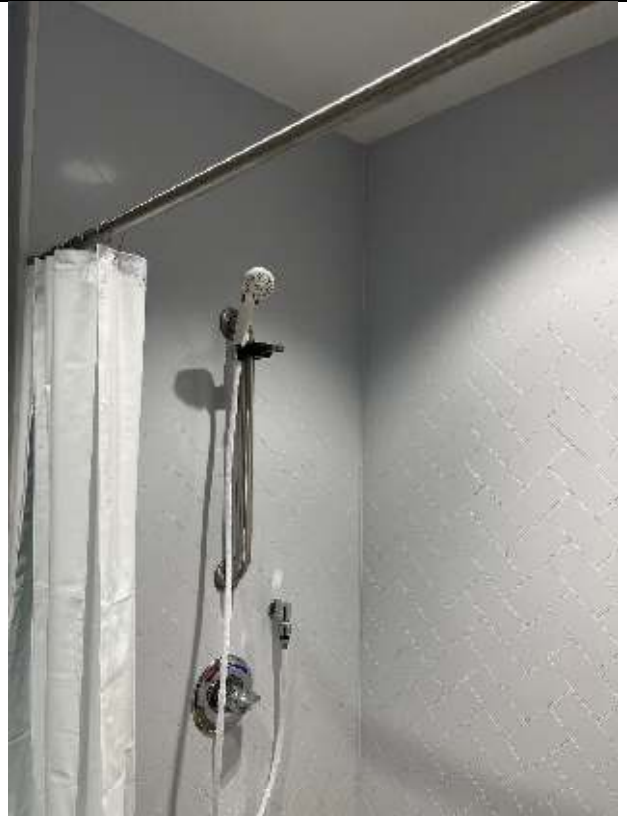
Photograph 6: New Shower 3

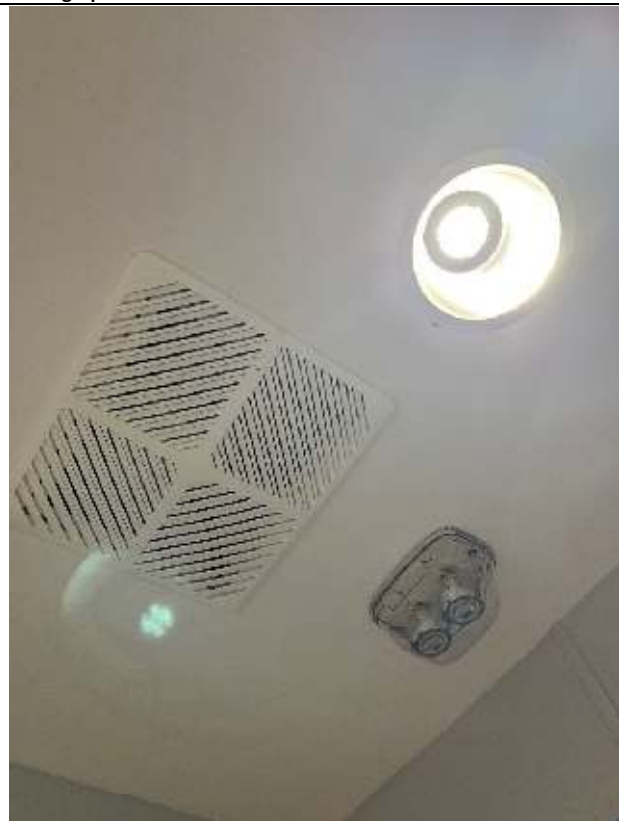
Photograph 7: Lighting and exhaust fan at New Shower 3

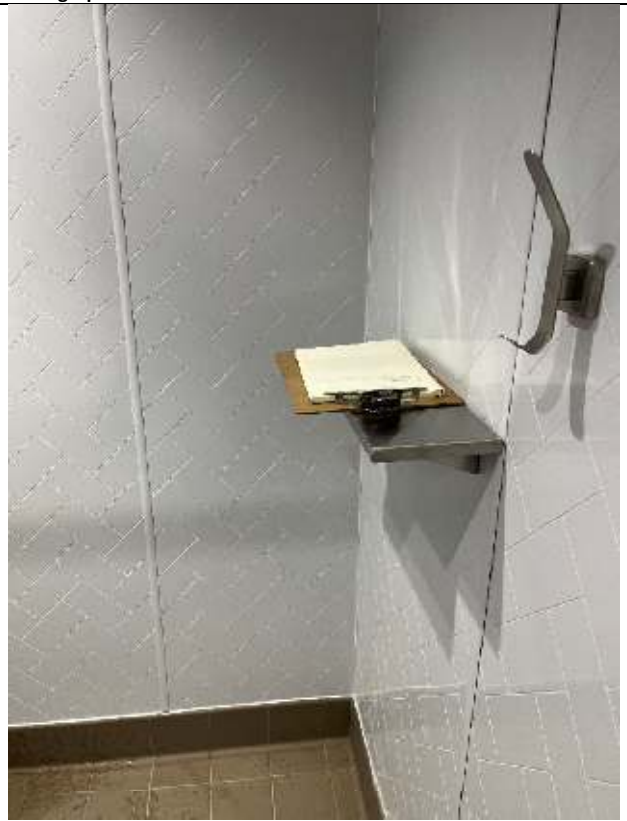
Photograph 8: Shelf and hook at New Shower 3

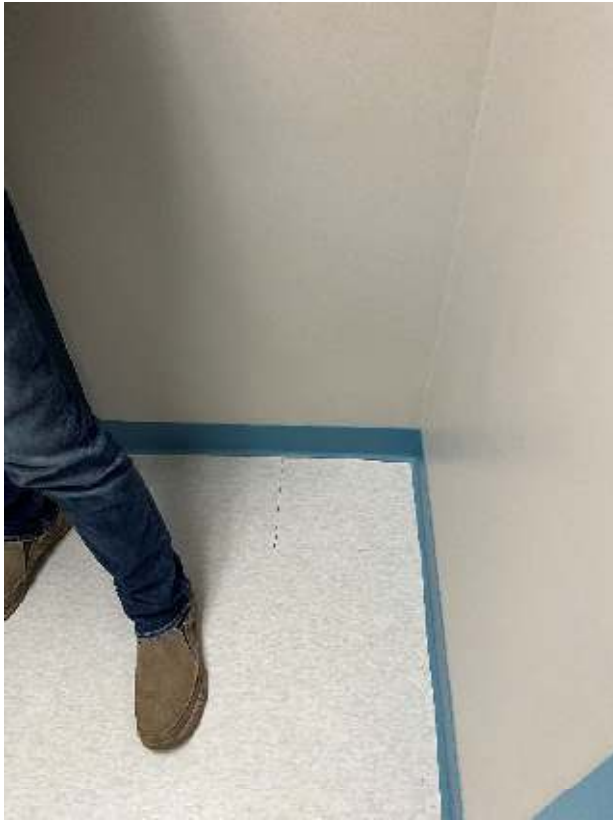
- 2.4 New resilient flooring and rubber base were installed at Washroom Vestibule 2, and the walls have been painted. – Photo 9
- 2.5 An exhaust fan outlet has been installed on the exterior face of the building. – Photo 10

Photograph 9: Washroom Vestibule 2

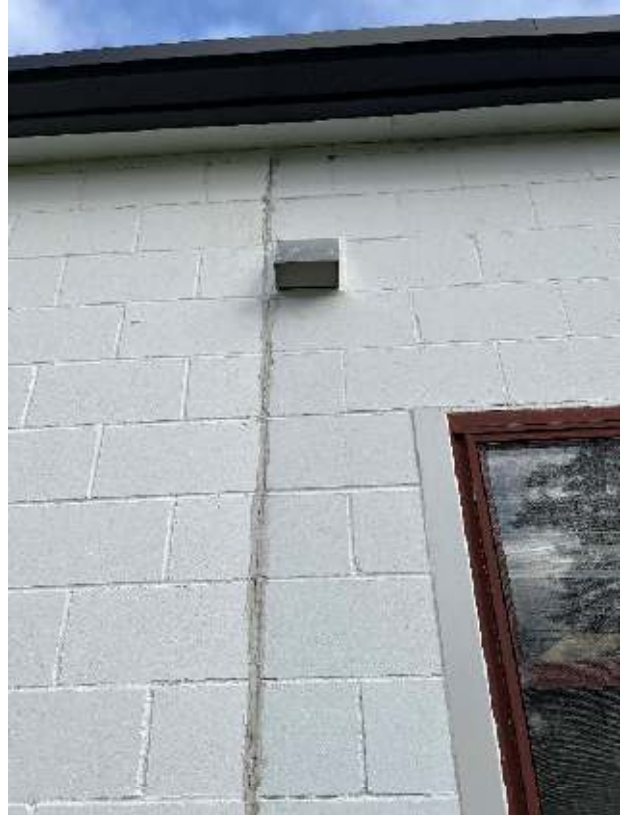
Photograph 10: Exhaust Vent Cover

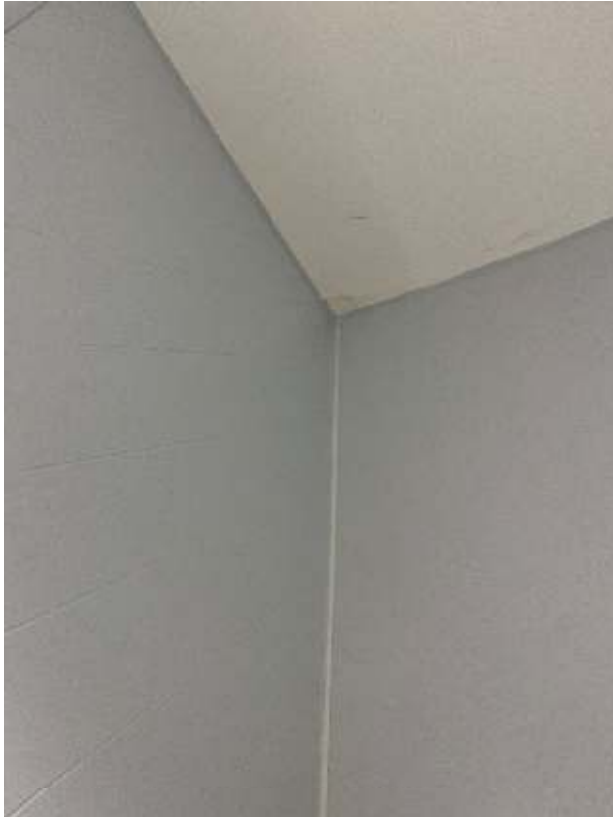
- 2.6 The painting around the perimeter of the ceiling in New Shower 3 was found to be deficient, with inconsistent application. This was corrected directly by M Builds and photographic documentation provided. – Photos 11 - 16

Photograph 11: Deficient painting at perimeter of New Shower 3

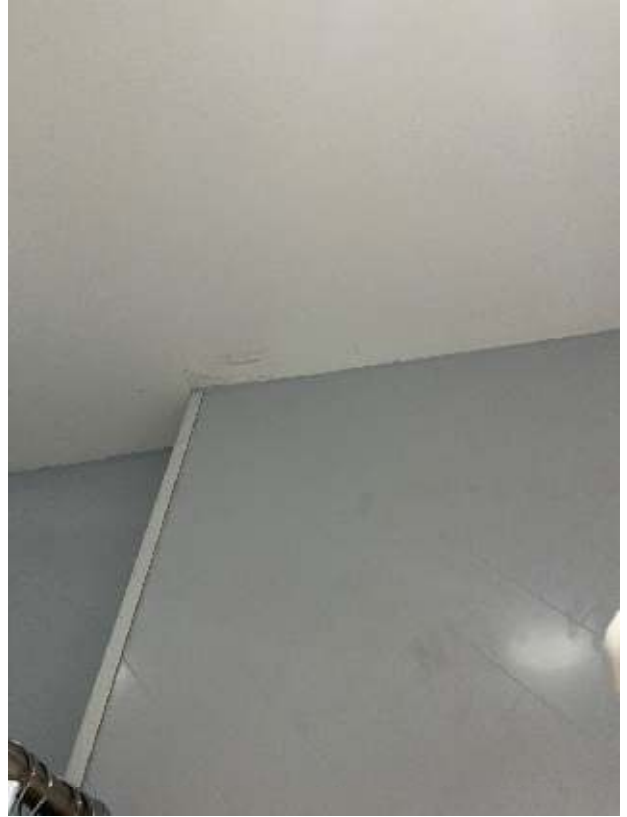
Photograph 12: Deficient painting at perimeter of New Shower 3

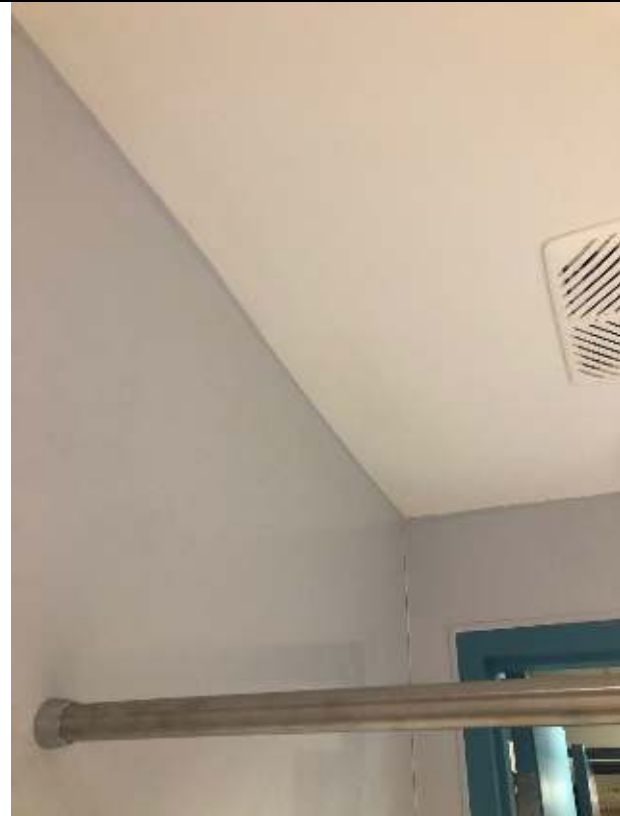
Photograph 13: Correction of deficient painting (photo by M Builds)

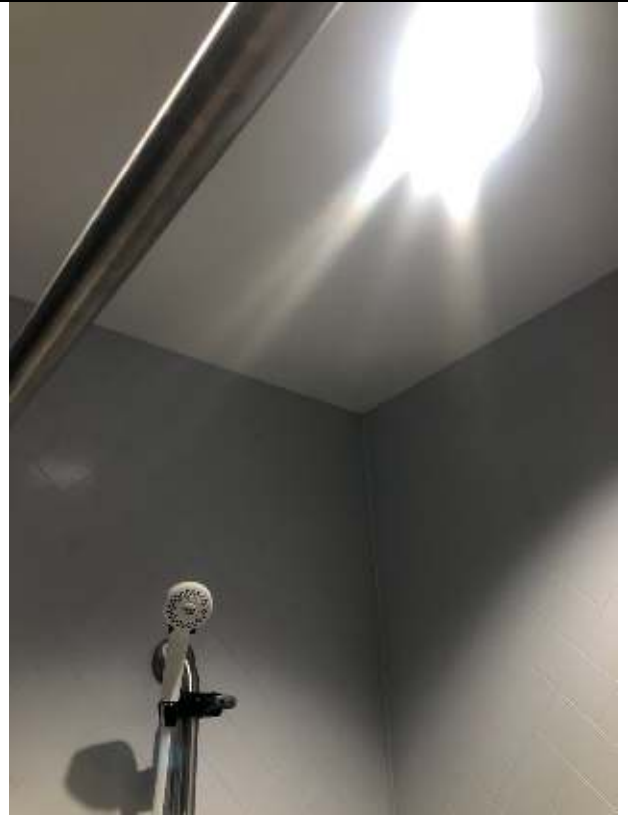
Photograph 14: Correction of deficient painting (photo by M Builds)

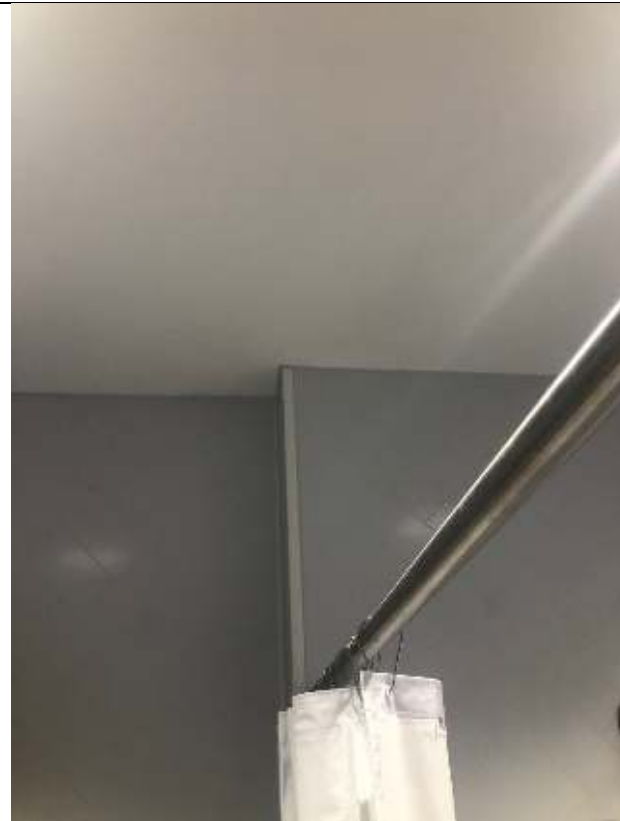
Photograph 15: Correction of deficient painting (photo by M Builds)

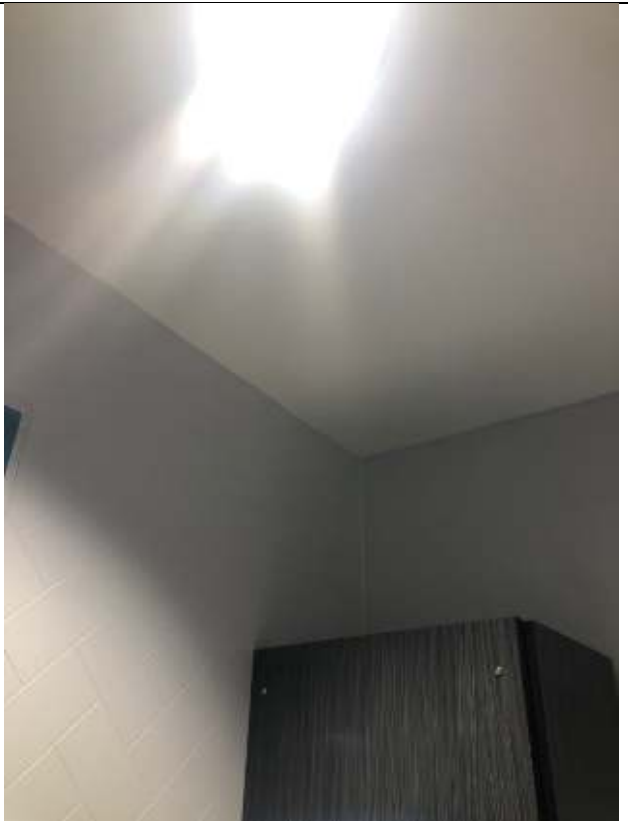
Photograph 16: Correction of deficient painting (photo by M Builds)
